FIELD REPORT

PROJECT: Contact Tank
 Greenburgh, NY

FIELD REPORT NO: 05
ENGINEER'S PROJECT NO: 99010

Work in Progress: Selective Demolition of the Contact Tank Roof Slab

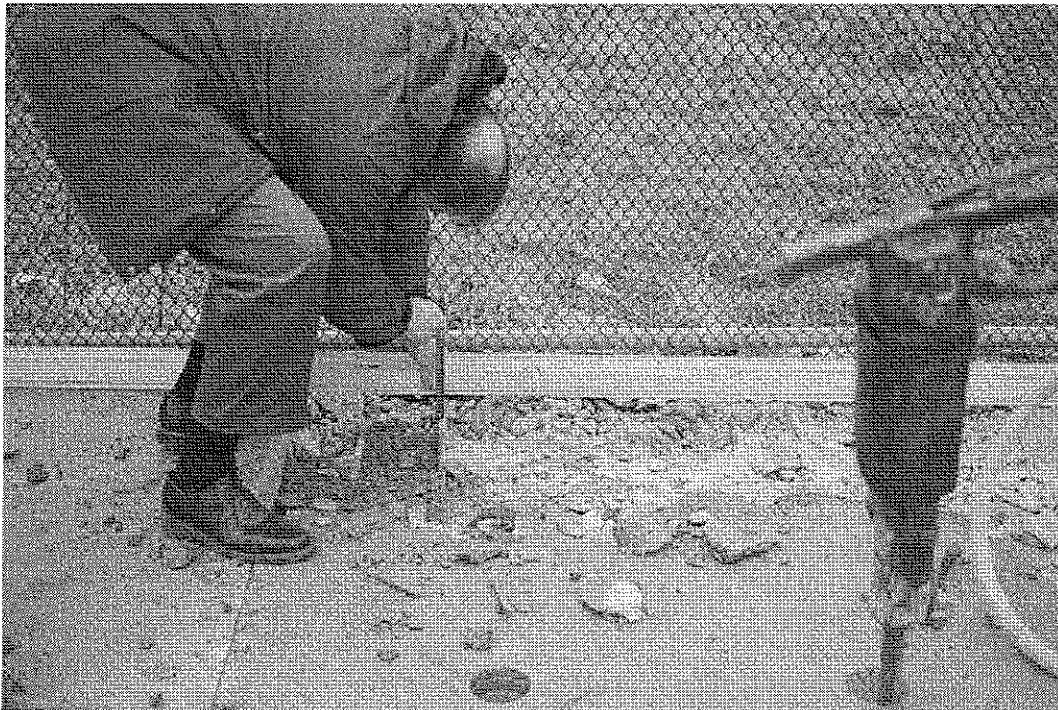
of the reinforcing bars. Clearances from the top of the slab to the top of the reinforcing bars was determined by placing an 8'-6" long strait edge parallel to the edge of the tank supported by the edges of the hole and measuring from the bottom of the straight edge to the top of the bar using a steel rule. (See Photo #1.) Clearances from the inside face of the wall to the wall reinforcing bars were measured using an adjustable square.

Photo No. 1 – East Side – Measuring Bar Position

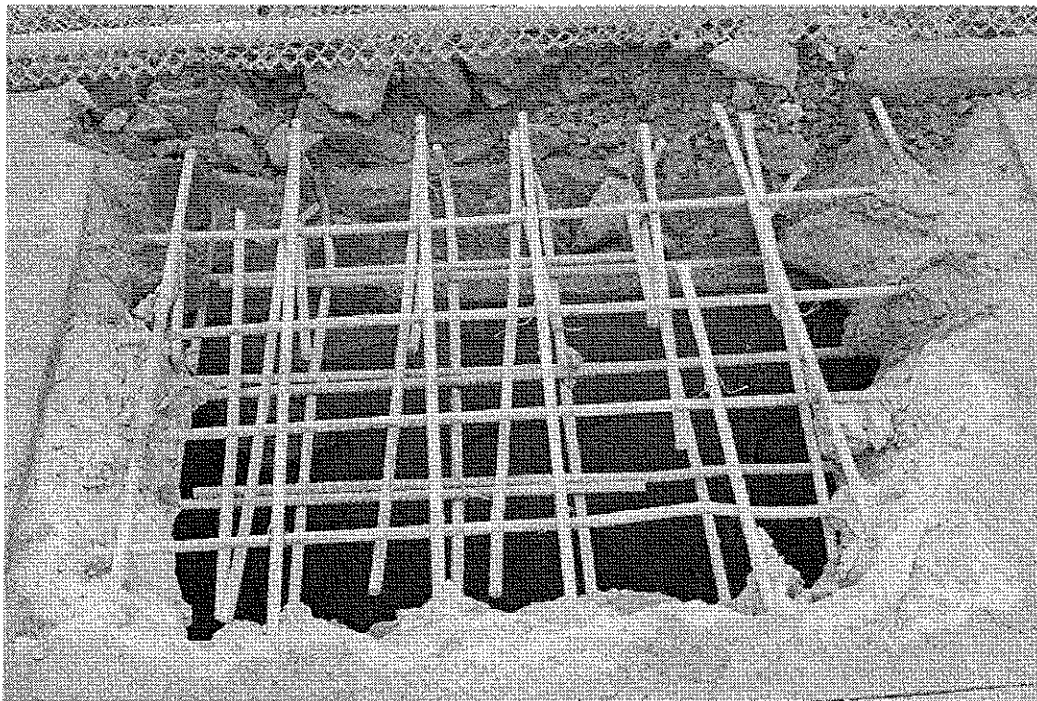
We found that the reinforcing bar placement that was observed did not conform to the contract drawings. While the bar size and spacing did conform to the drawings, we found that the clearances between the reinforcing bar and the concrete surfaces did not conform to the contract drawings. These findings are shown on sketches SK 040404-1, SK 040404-2, SK 040404-3 and SK 040404-4. The dimensions that are shown on these sketches are the averages of the dimensions taken to each bar in each area. (See photo #2 through #7 for the arrangement of the reinforcing steel.)

Photo No. 2 – East Side Bar Arrangement

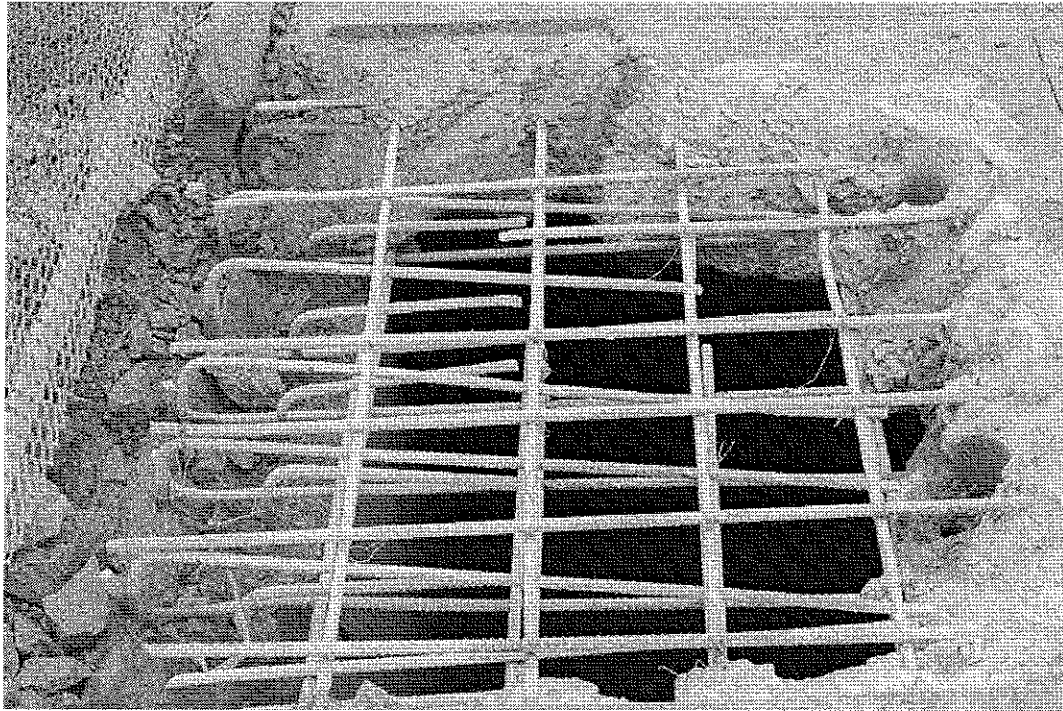
Photo No. 3 – East Side Bar Arrangement

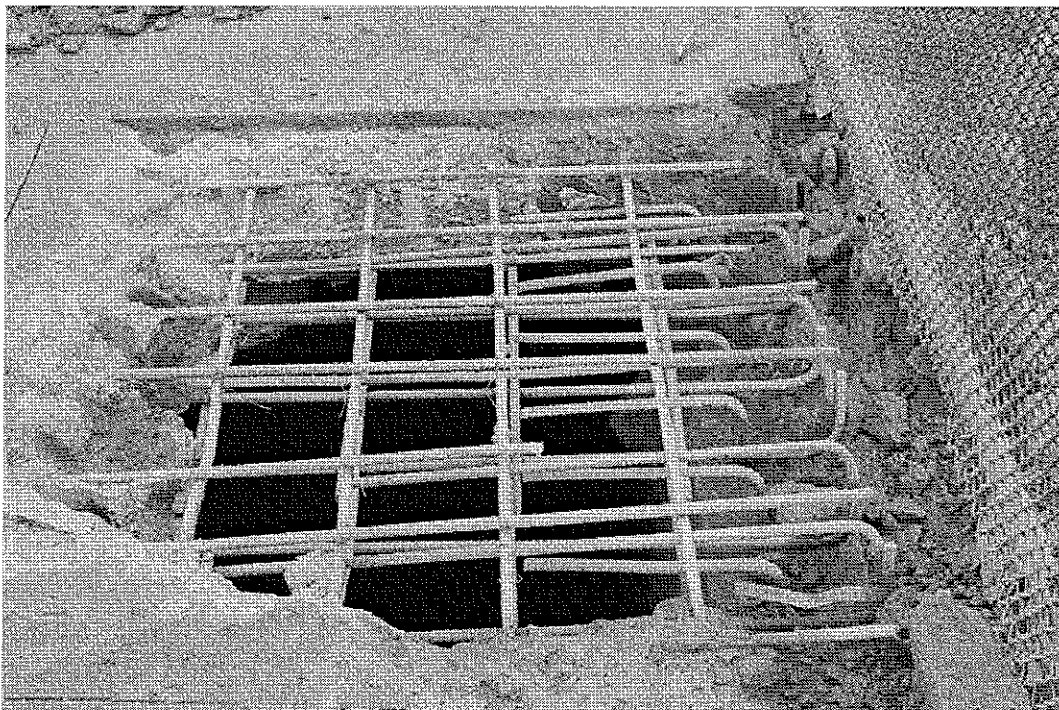
Photo No. 4 – East Side Bar Arrangement

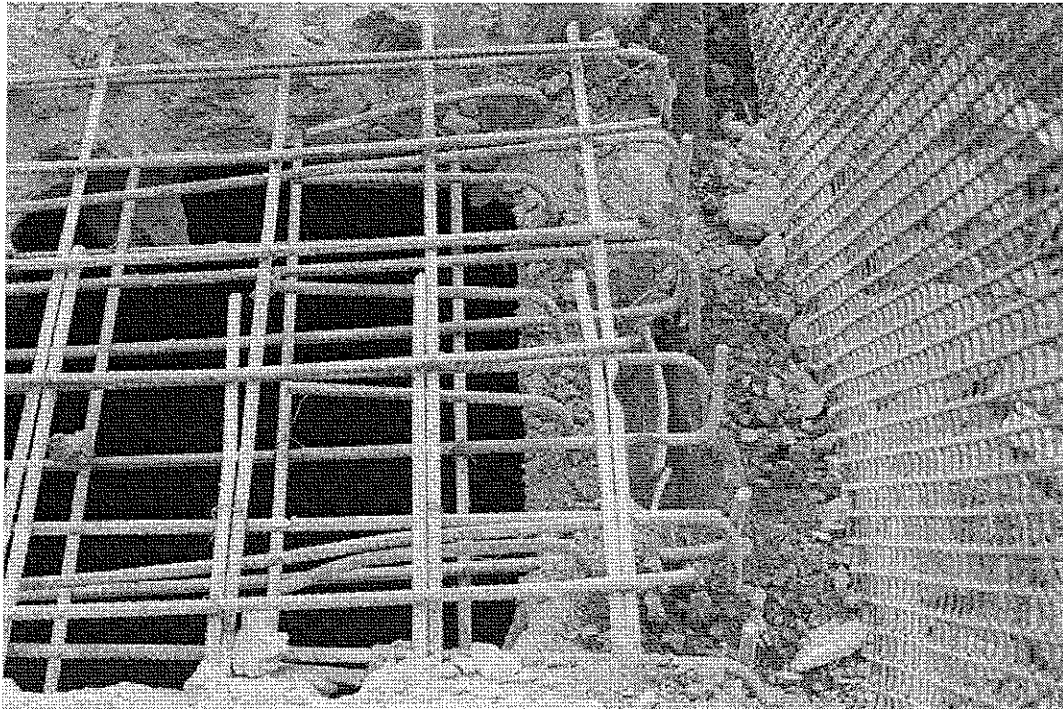
Photo No. 5 – West Side Bar Arrangement

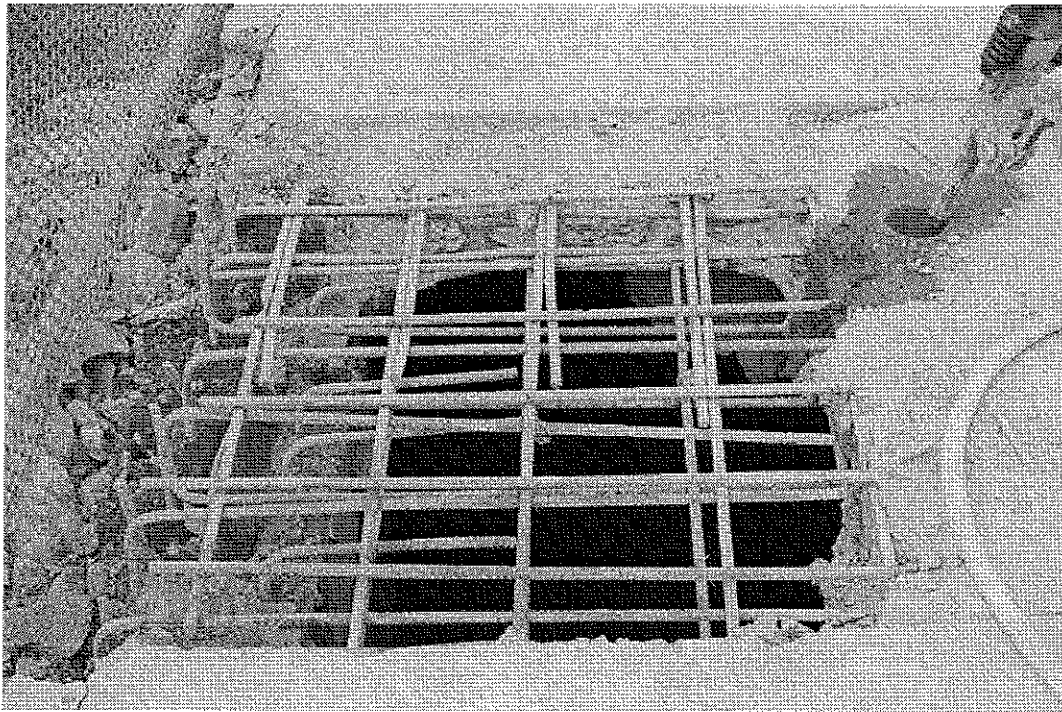
Photo No. 6 – West Side Bar Arrangement

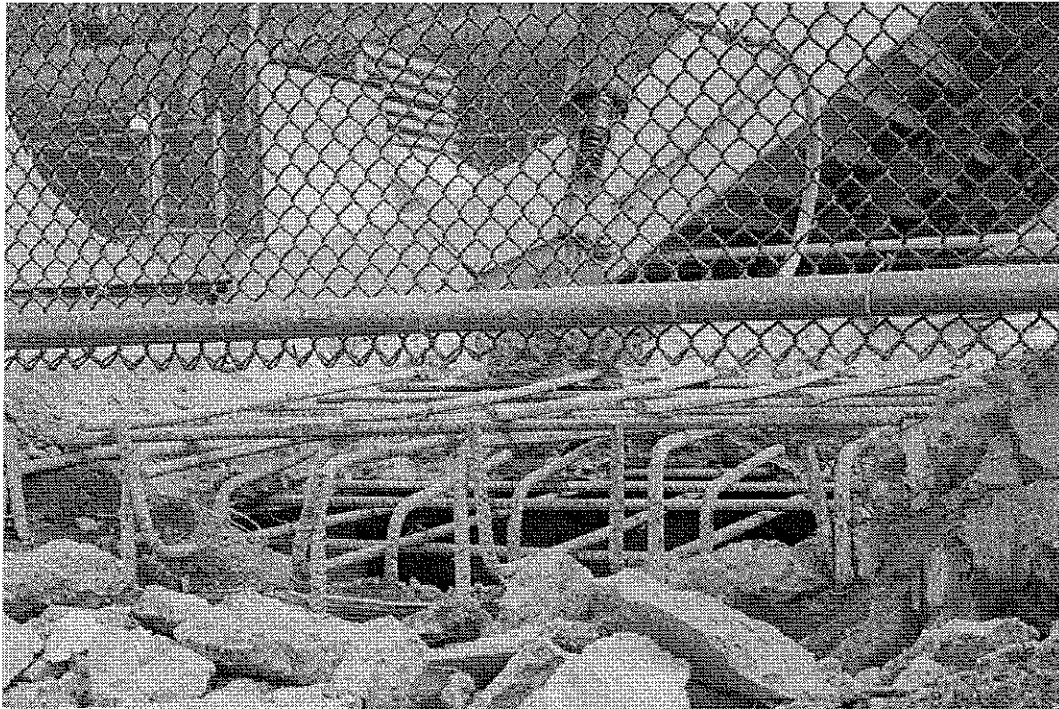
Photo No. 7 – West Side Bar Arrangement

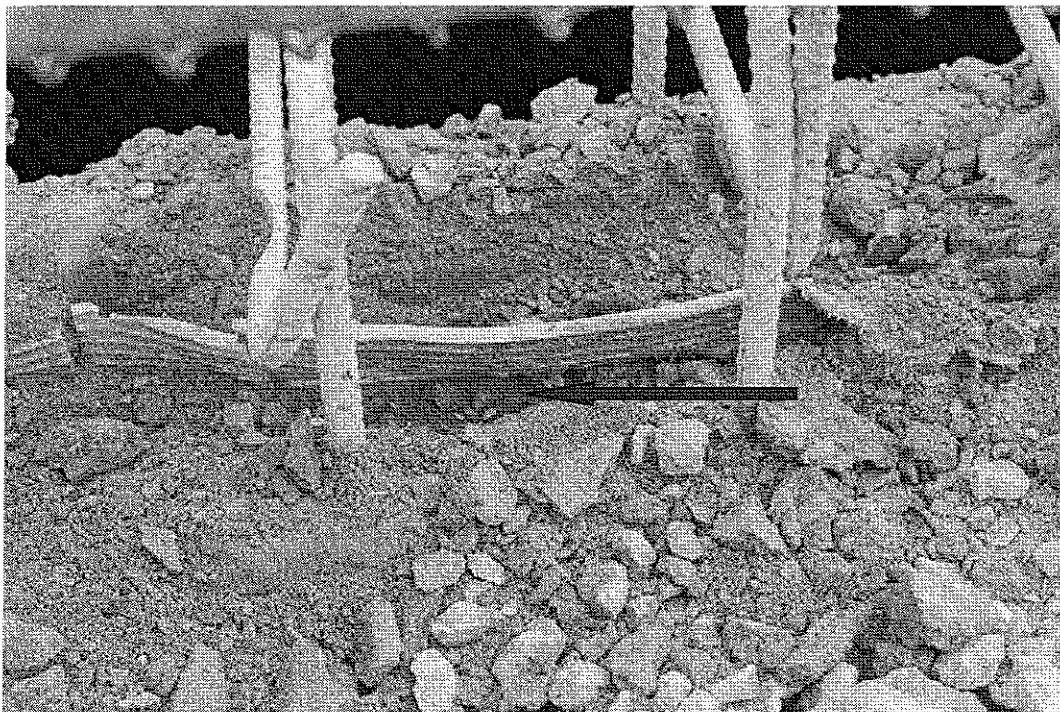
We found that the water-stop at the east side was folded over at approximately 45 degrees in one area. We also found that clods of dirt had been encapsulated up against the water-stop by the concrete at the west side when the concrete had been placed. Both of these conditions would prevent the proper function of the water-stop. (See photo #8 for the impression of the folded over water stop at the east side and photo #8 and #9 for the clods of dirt at the west side waterstop.)

Photo No. 8 – West Side – Soil in Construction Joint

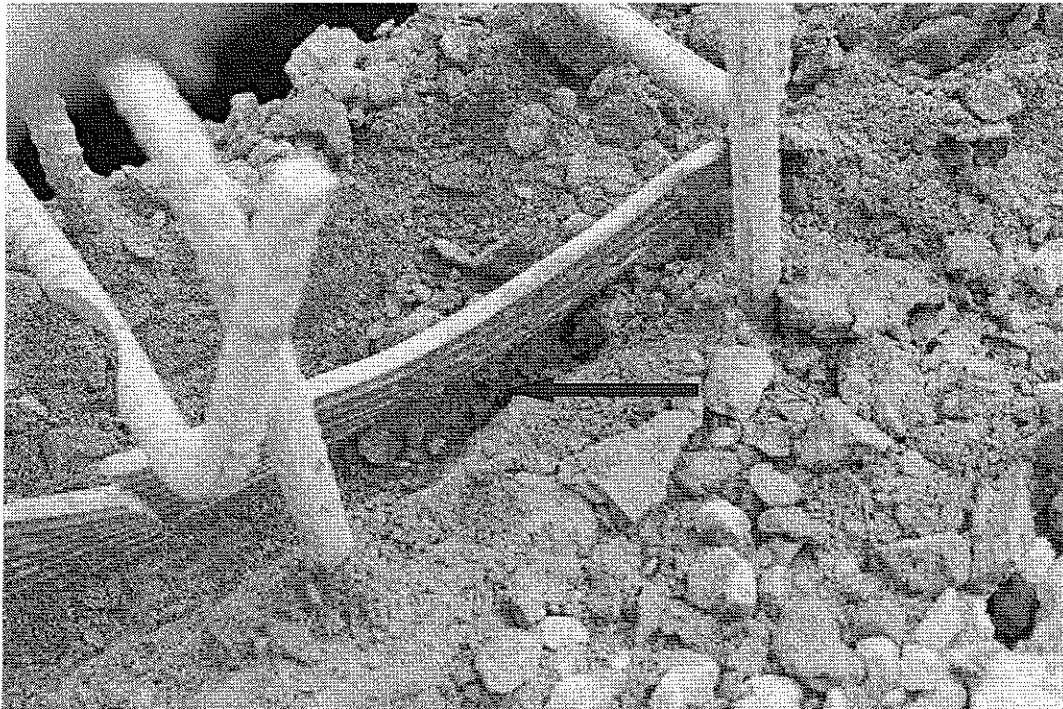
Photo No. 9 – West Side – Soil in Construction Joint

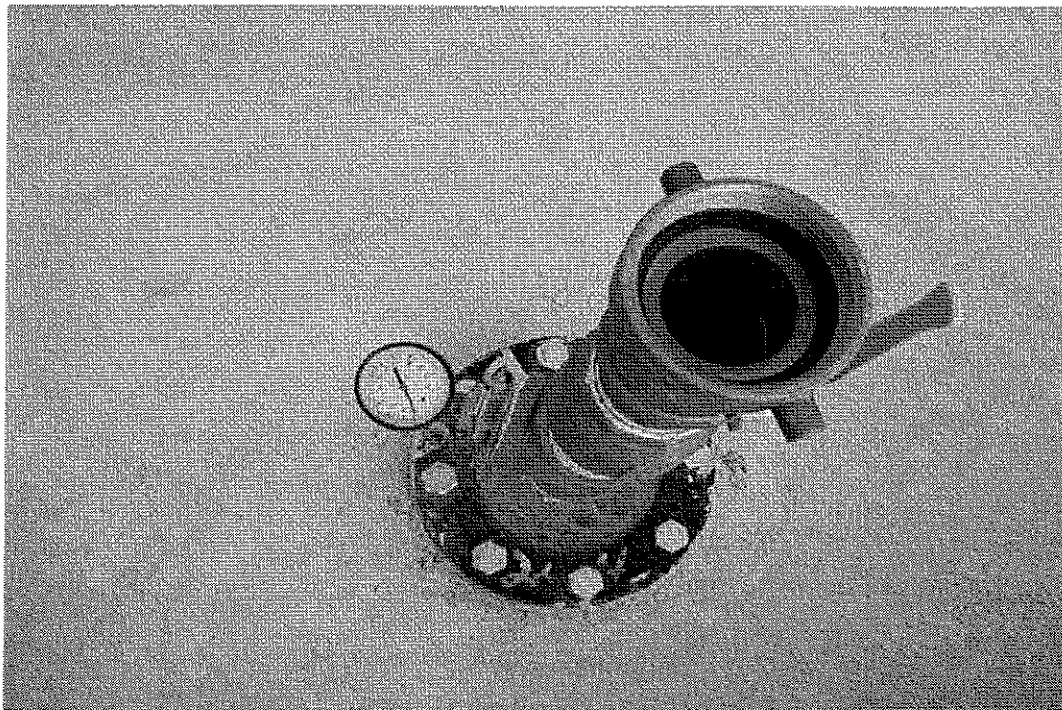
In discussions with Louie Ferrera on March 25 and 26, he revealed that during the pressure test that Spectra Serve conducted the test pressure may have reached 15 pounds per square inch which was greater than the test pressure. It should be noted that the gauge that had been used for the test has calibrated between 0 and 100 psi. and that during the test the needle that registered the pressure fluctuated erratically over a wide range of pressures. (See photo 10.)

Photo No. 10 – Test Gage From Pressure Test
